# Investigate size of annulus leak rates on four suspect wells

B annulus casing pressure investigation

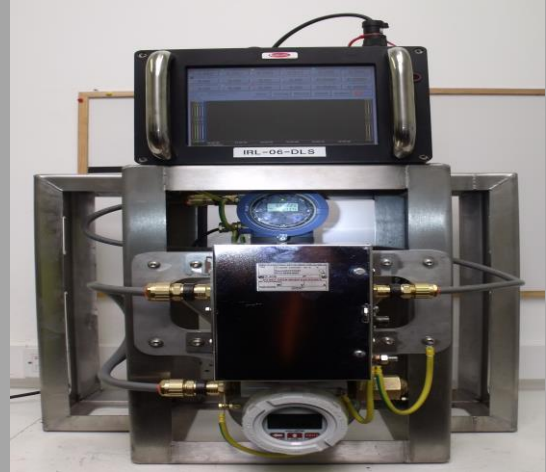
Full Coriolis measurement and data recording skid to collect all required information for analysis

*Operational results indicated a leak in the tubing to annulus of one well: Intervention leak seal services were asked to repair the leak. The operation successfully sealed the leak*
