## Well Head Upper MS-T seal leak

### Industry Challenge

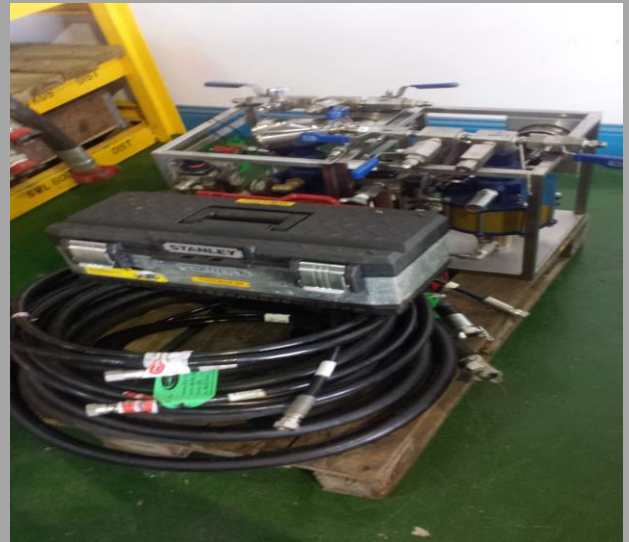
- Leak identified during Intervention integrity testing team
- Average leak rate : 2.2L/min
- Customer required immediate and urgent response to seal the leak

Unable to pressure test MS-T lower seal due to Upper seal leak

- Mobilised Intervention specialist sealmaker equipment within 24 hours
- Upper MS-T Seal established and tested to 1600 psi
- Back flow leak test performed successfully

- Intervention integrity testing identified leak
- Designed leak sealant solution applied using intervention designed pumping skid
- Leak sealed to customer acceptable parameters within 72 hours of discovering the leak
